## RESTORATION OF THE DOGS' HOME

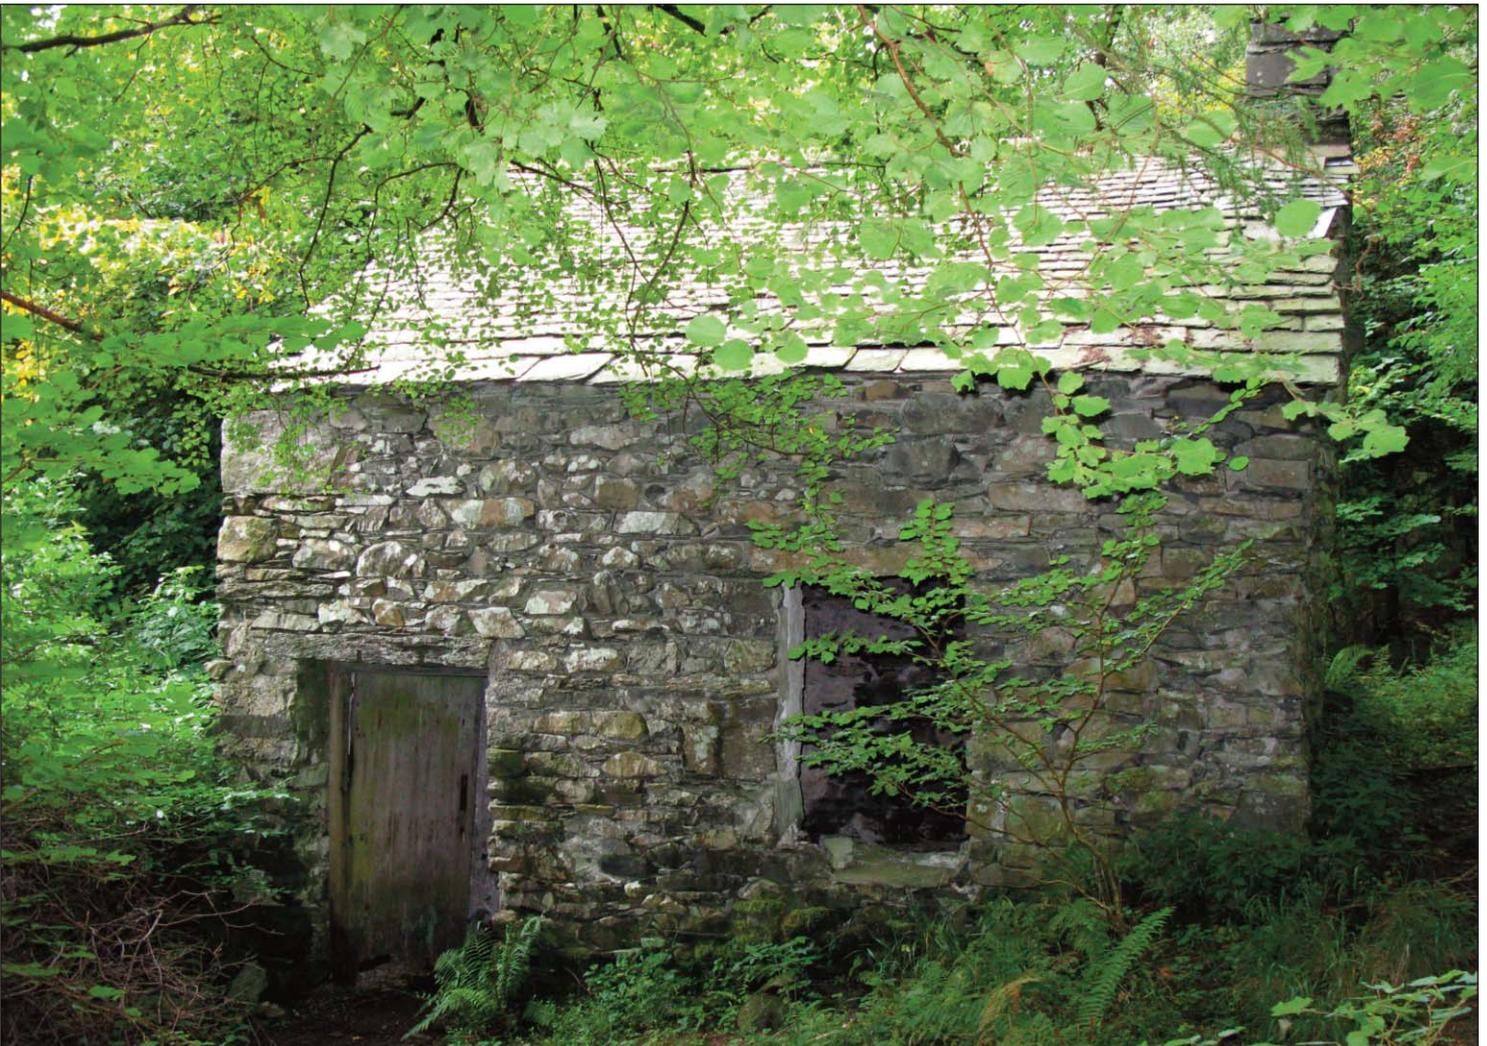
The Dogs' Home prior to restoration commencing. Overgrown, unloved, and slowly falling apart

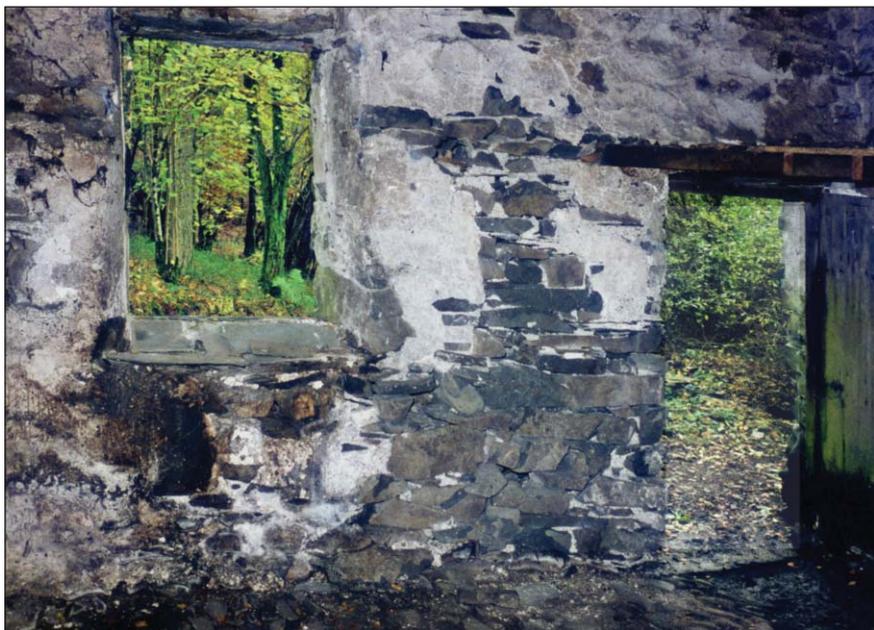
The interior of the front wall. No window, badly rendered, crumbling

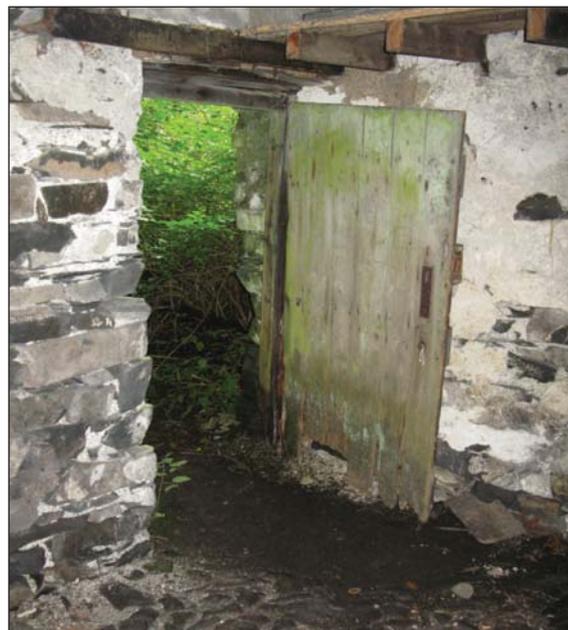
The front door. Falling apart and off its hinges

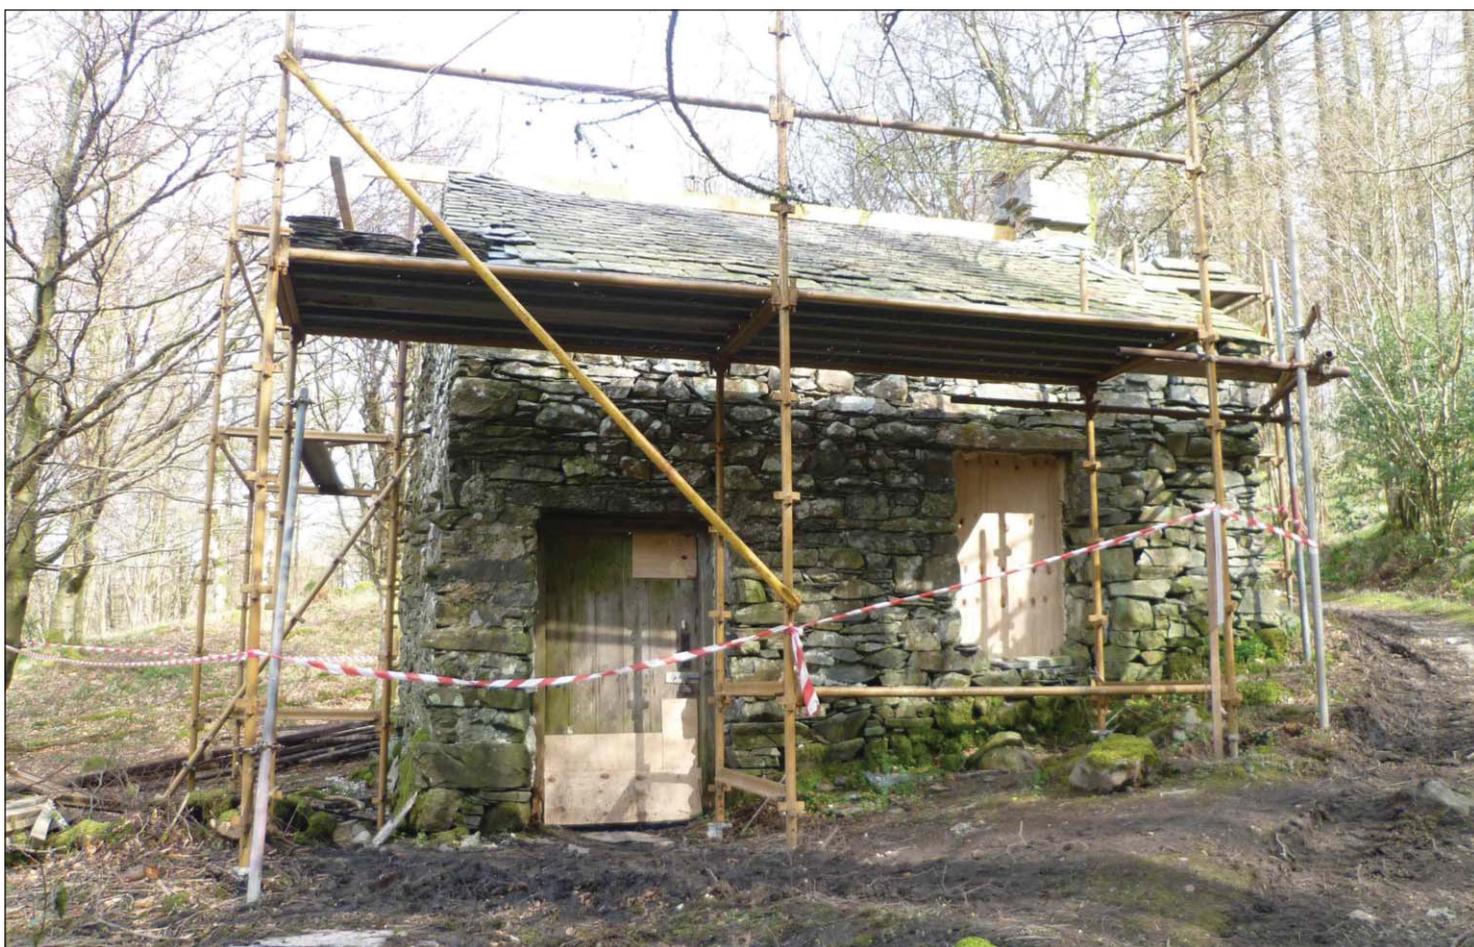
Mid-restoration. Scaffolding up and the roof about to come off for repairs to the timbers. Encroaching undergrowth cleared away

Mark identified one major problem: the roofing timbers were rotten, leading to the tiles coming off. Indeed we found a piece of rafter, with some tiles still attached, on the ground at the back! Looking inside, the main central beam wasn't even attached to the end gable. This could have been rot, but was actually indicative of a much bigger problem: that the eastern gable was bowing outwards significantly and had pulled clear of the central beam, leaving this unsupported at the end.

However, the bad news was that, in Mark's view, the roof needed a complete replacement; and worse, that the walls needed stabilising. He reckoned there wasn't much point doing a temporary roof repair, nor would it be easy to do, as the rotten and broken timbers wouldn't hold any roof nails.

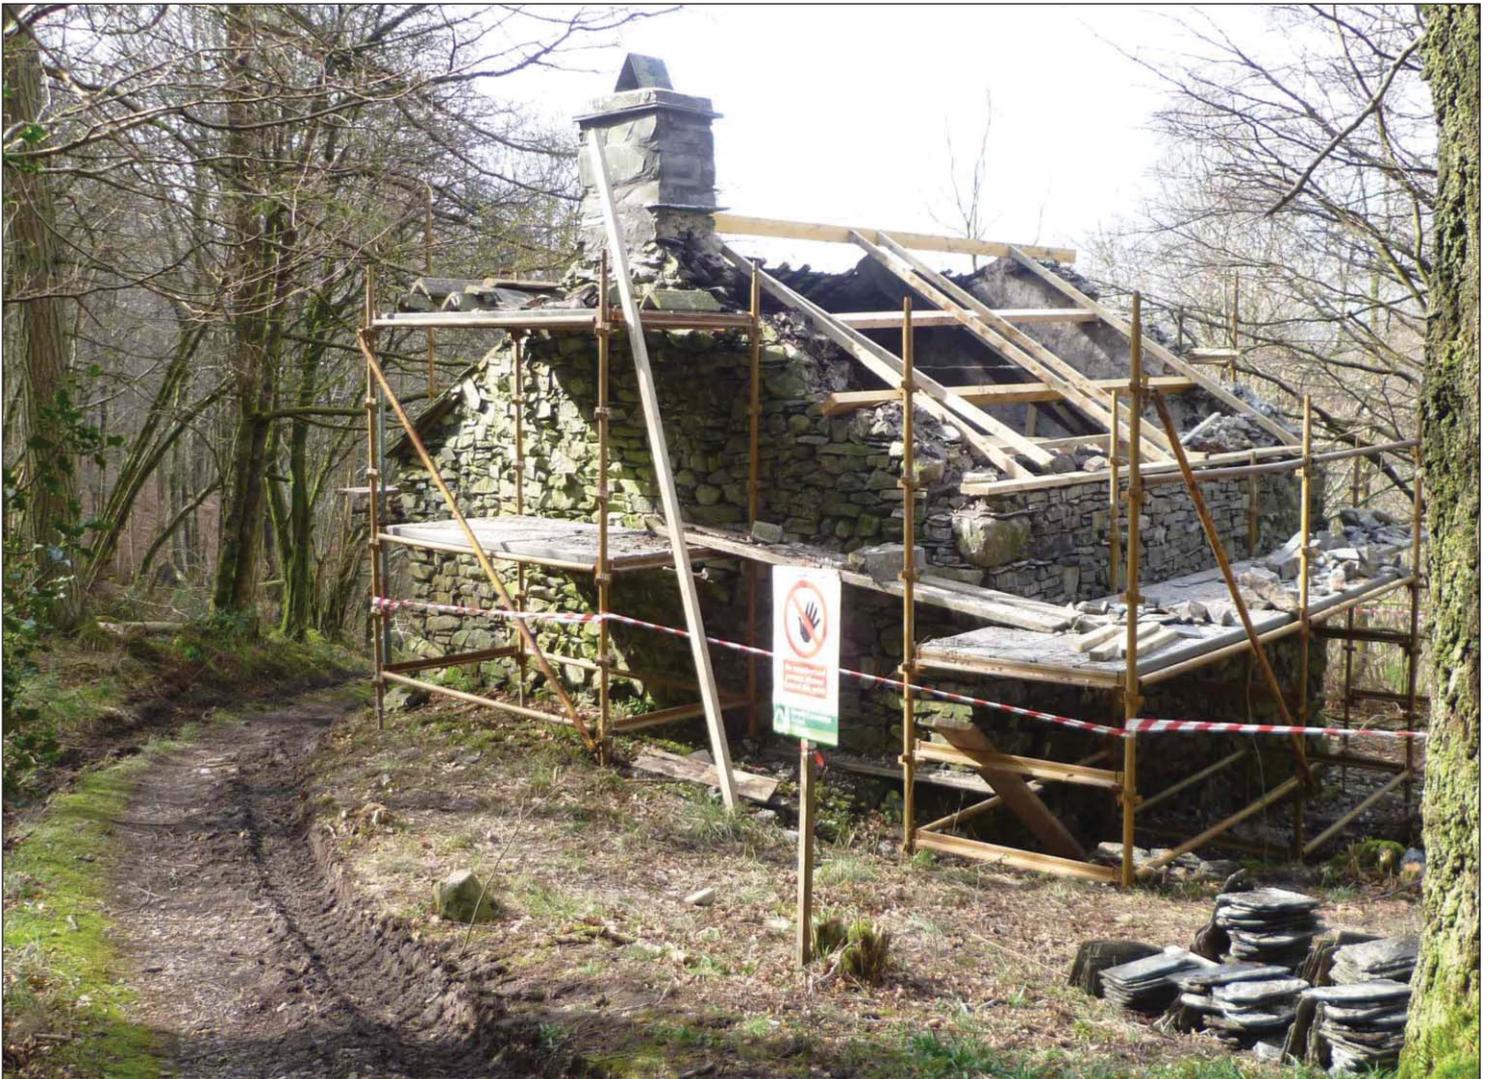
View from up the track showing the roof timbers in the process of replacement. Note 'elf 'n safety' signs and caution tape!

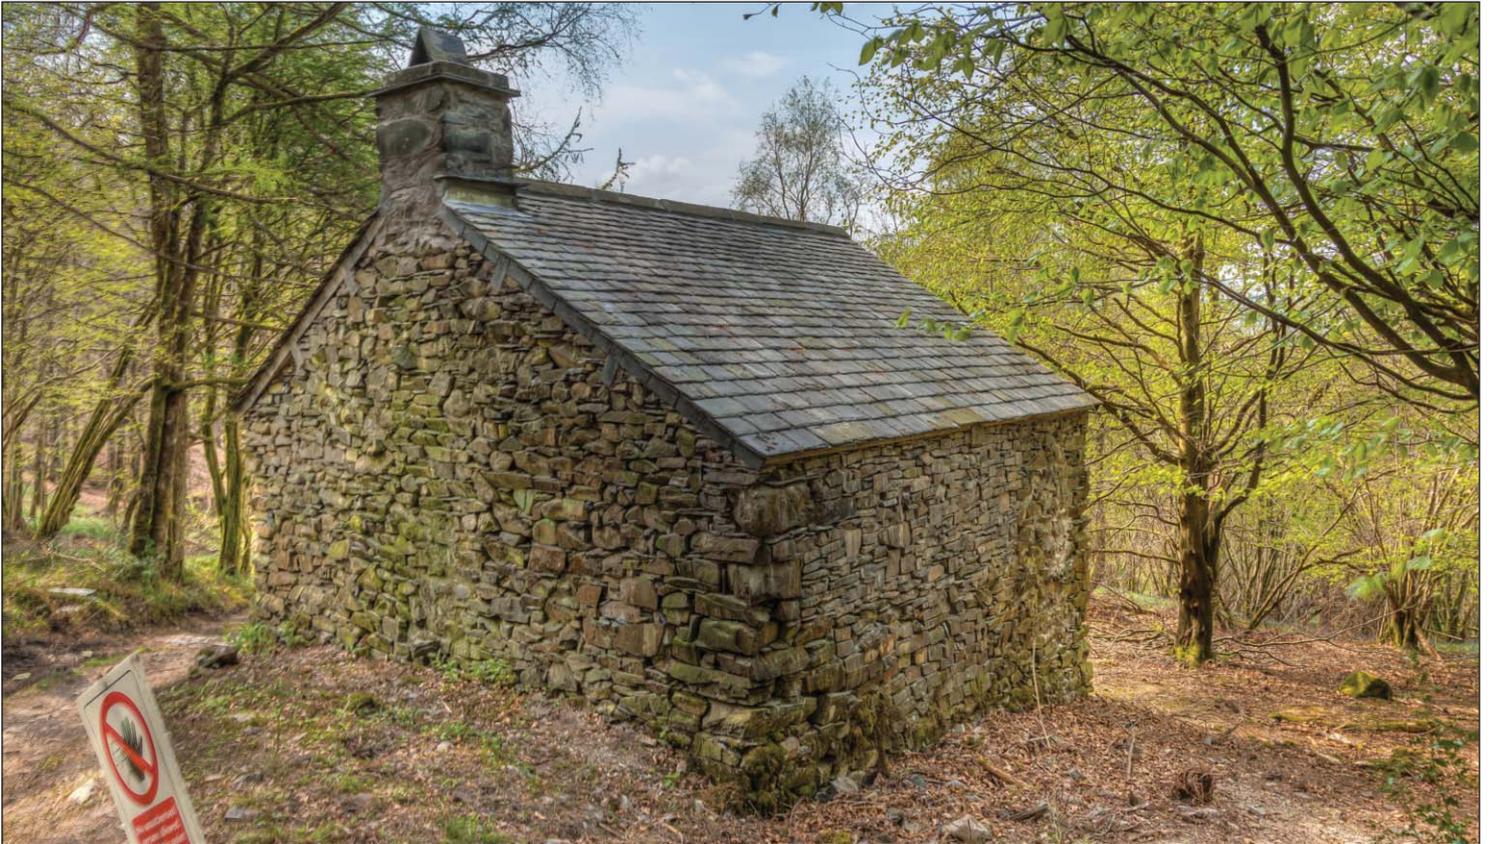
Immediately post-restoration. Slate tiles back on, scaffolding gone and site beginning to recover

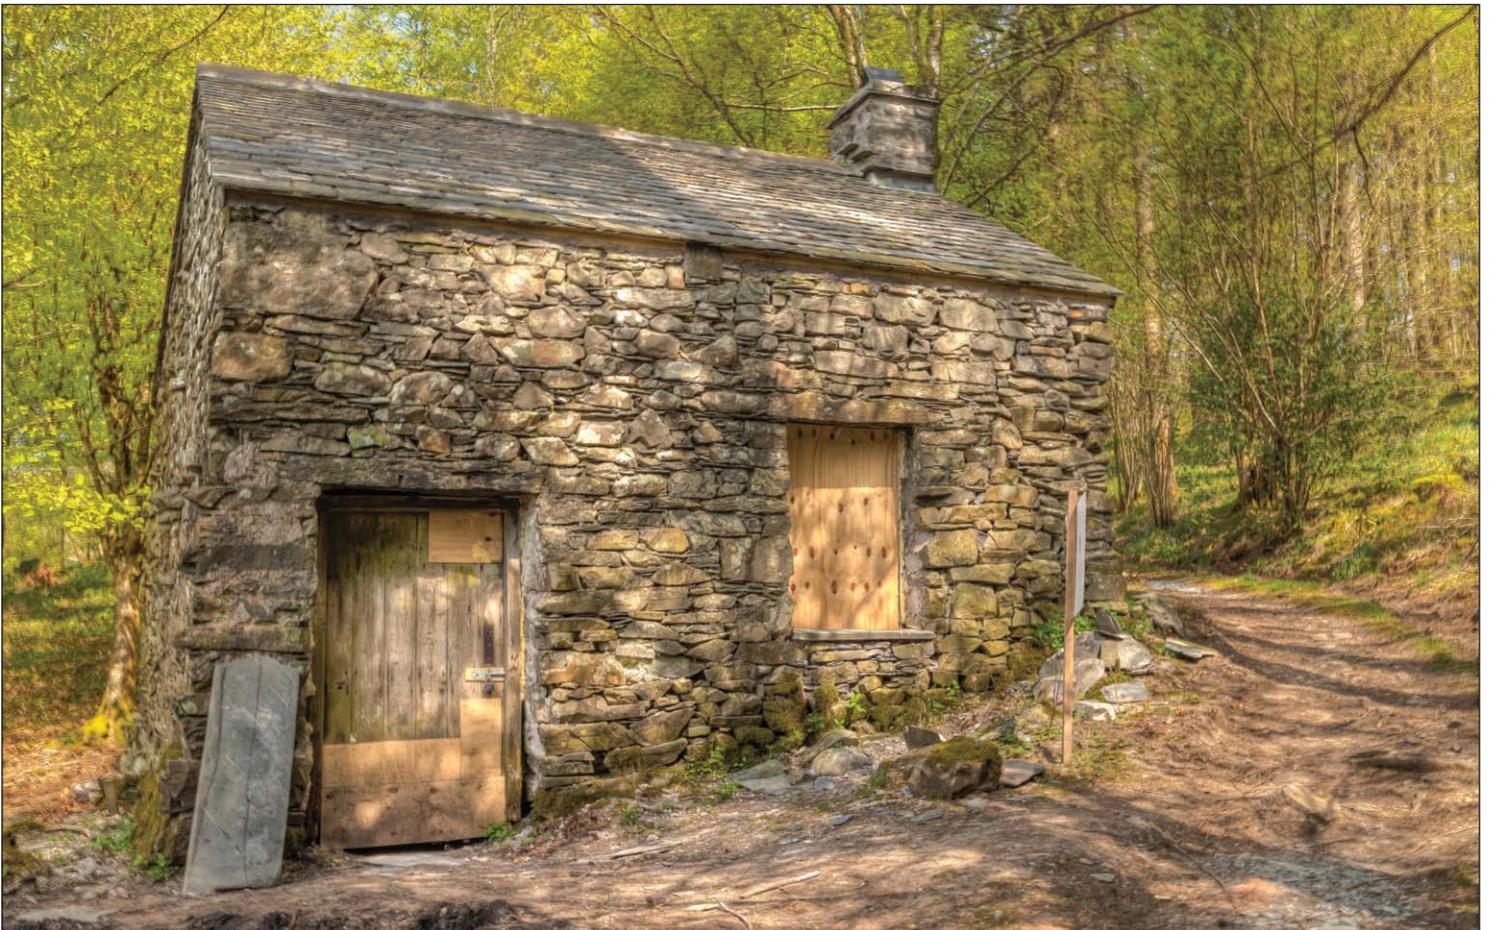
View from the front, post-scaffolding removal, but prior to door and window fitting

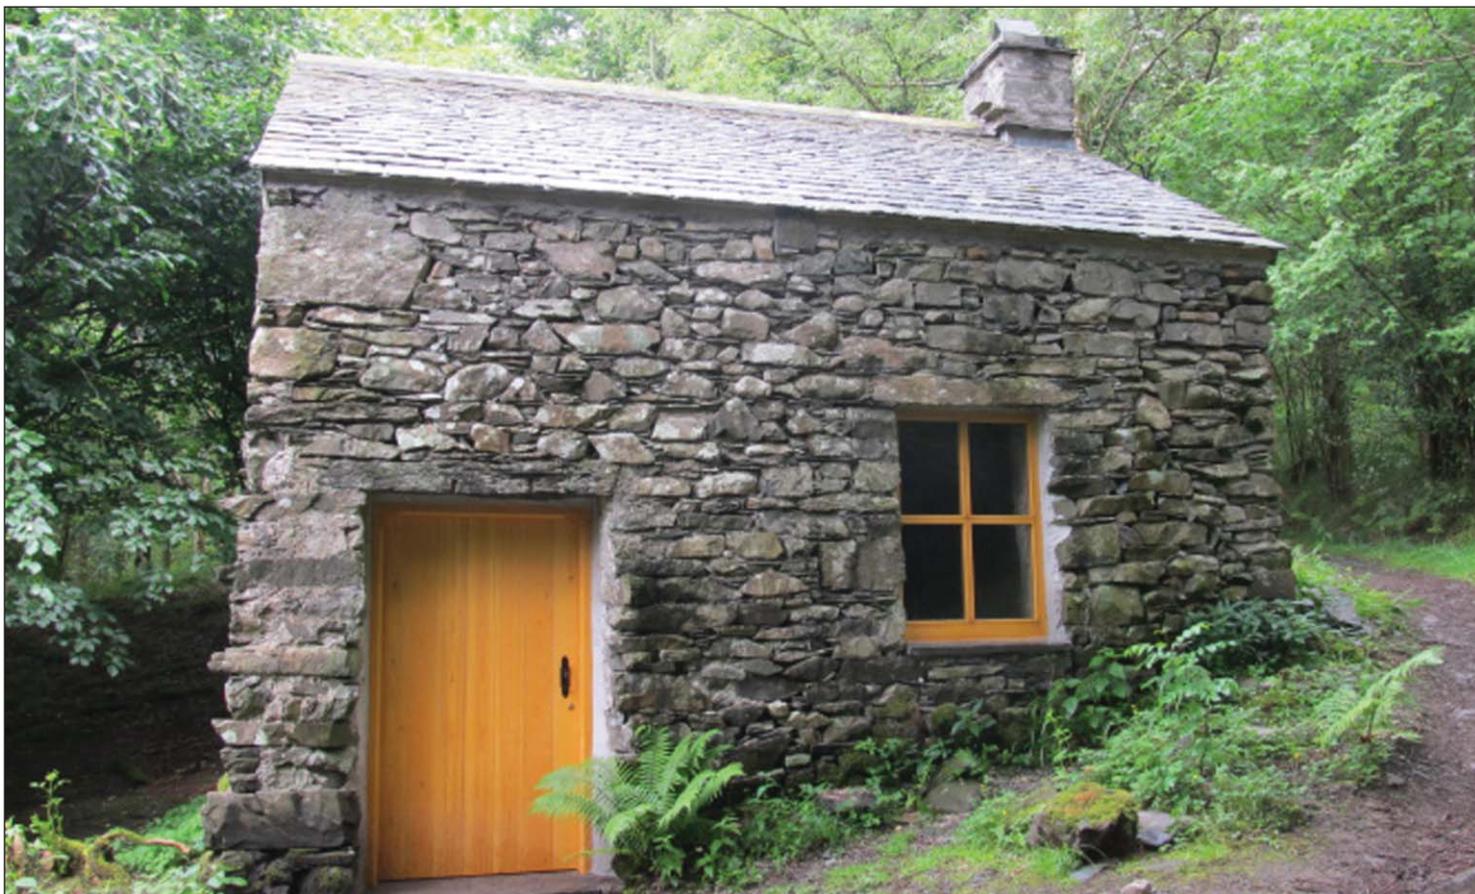
Restoration complete. Door replaced. Brand new window. A suitable abode for any number of Picts or Martyrs!

He found an additional amount of about £3,000 in FC budgets, and the restoration work was back on the agenda. The work itself took place in February and March 2014. Some might criticise the glazing in the windows (which were originally, and in *PM*, unglazed), but Mark and the FC wanted this building to last and so they were keen to make it weather proof.
